Enhanced Preliminary
Assessment Report:

Pontiac Storage Activity
Pontiac, Michigan

March 1990

E.C. Jordan Co.
33493 Fourteen Mile Road
Suite 50
Farmington Hills, MI

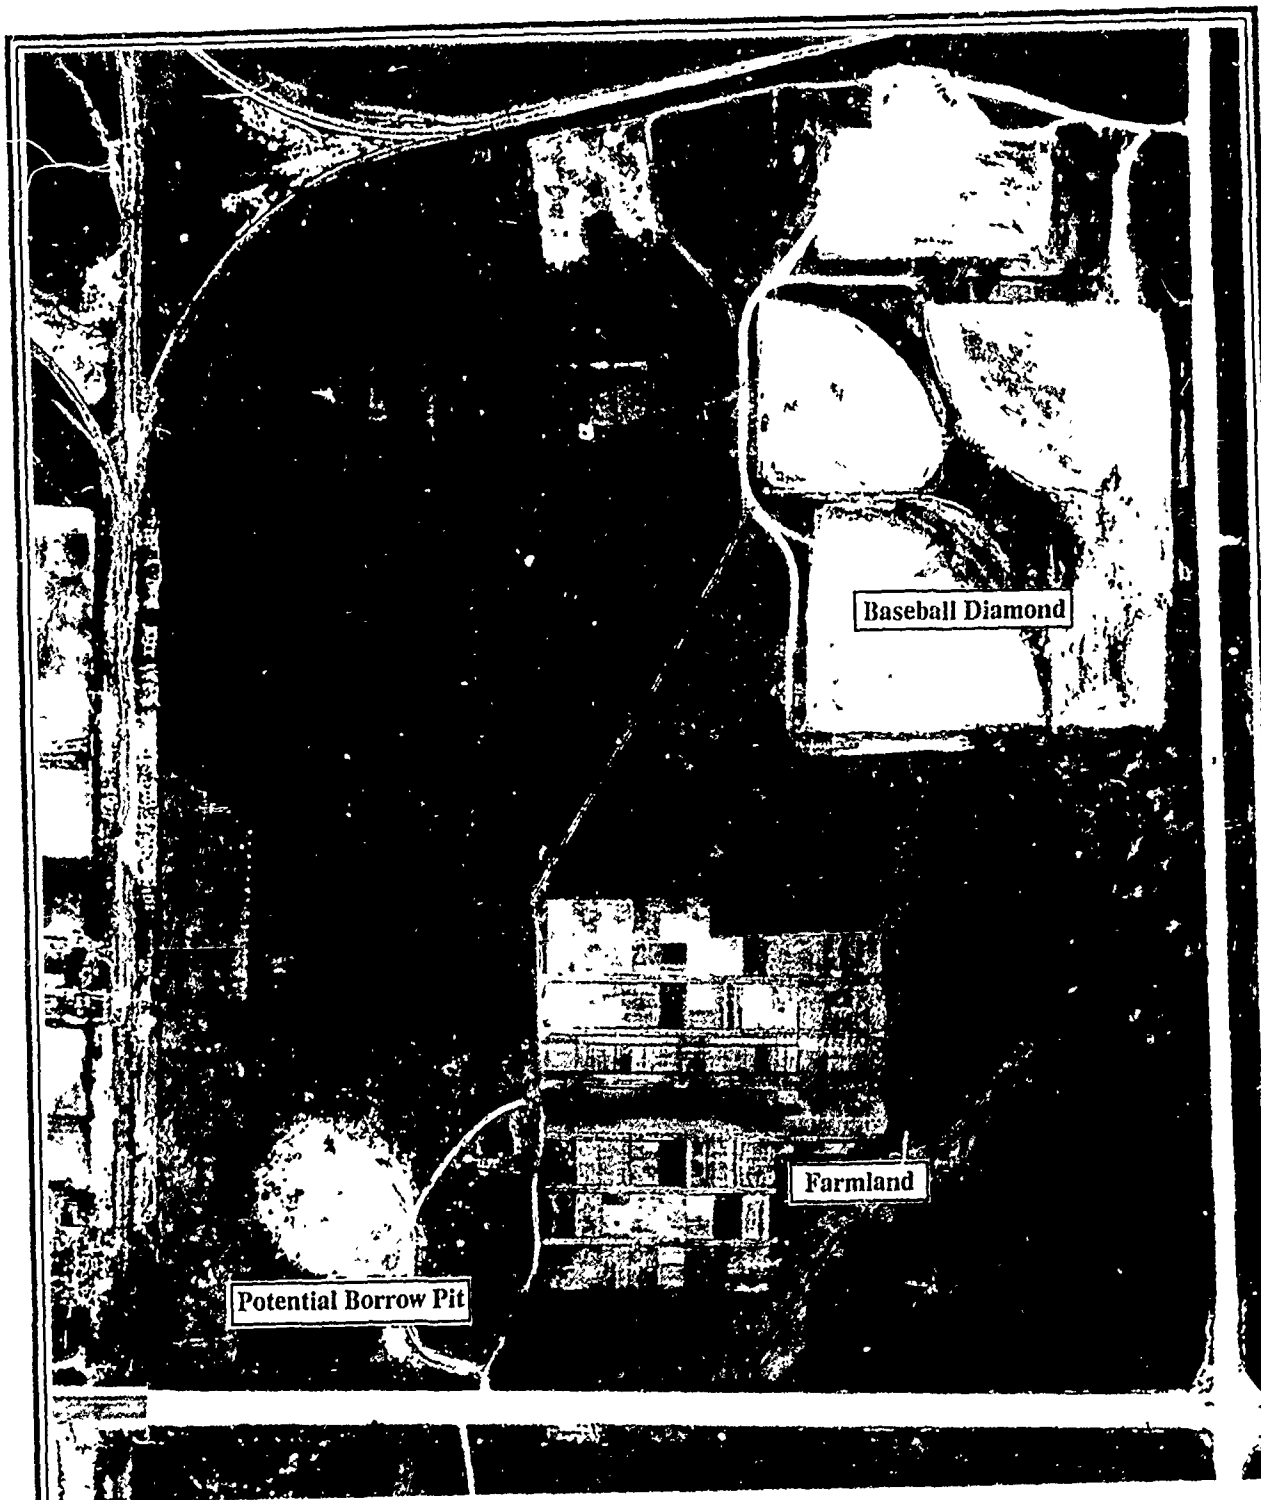
FIGURE 5
AERIAL PHOTOGRAPH-1949
PONTIAC STORAGE ACTIVITY, TACOM
PONTIAC, MICHIGAN

In the 1949 photograph, the site is undeveloped. Apparent baseball diamonds, under construction or in the process of being regraded, are located to the east and farmed land is apparent to the southeast as well as to the west. A circular ground-scar is evident to the south. Though the cause of this scarring is not known, it is possible that this area is a borrow pit related to the construction of GMC facilities to the south.

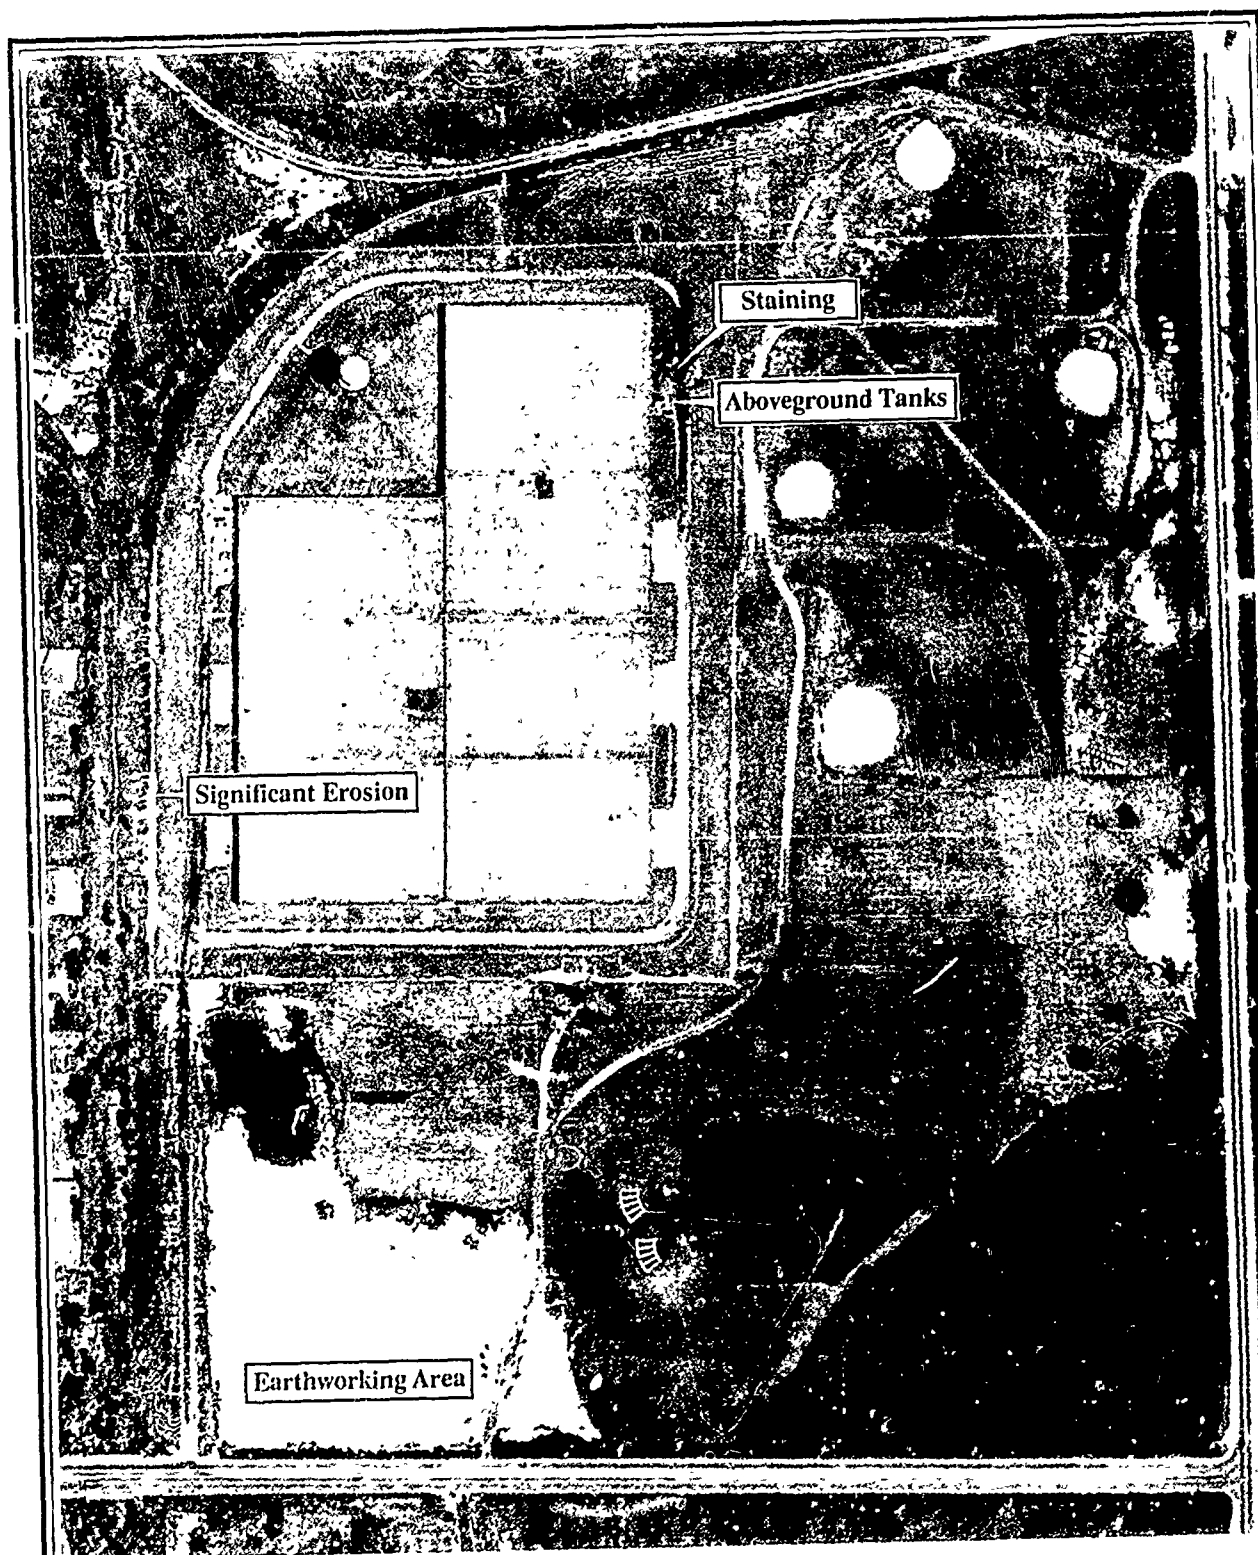
FIGURE 8
AERIAL PHOTOGRAPH-1961
PONTIAC STORAGE ACTIVITY, TACOM
PONTIAC, MICHIGAN

In the 1961 photograph, the west roadway still appears to be stained. Additionally, similar staining is evident on the PSA's northeast roadway. Two small white dots are also present in the northeast corner of the site. It is speculated that these two dots are aboveground tanks possibly used for storage of gasoline or diesel fuel used at the site. The surface scarred area south of the PSA appears to be in the process of being regraded in the 1961 photograph. Several cars are evident at the northwest corner of this area indicating activity. Erosion is evident along the site's western border.

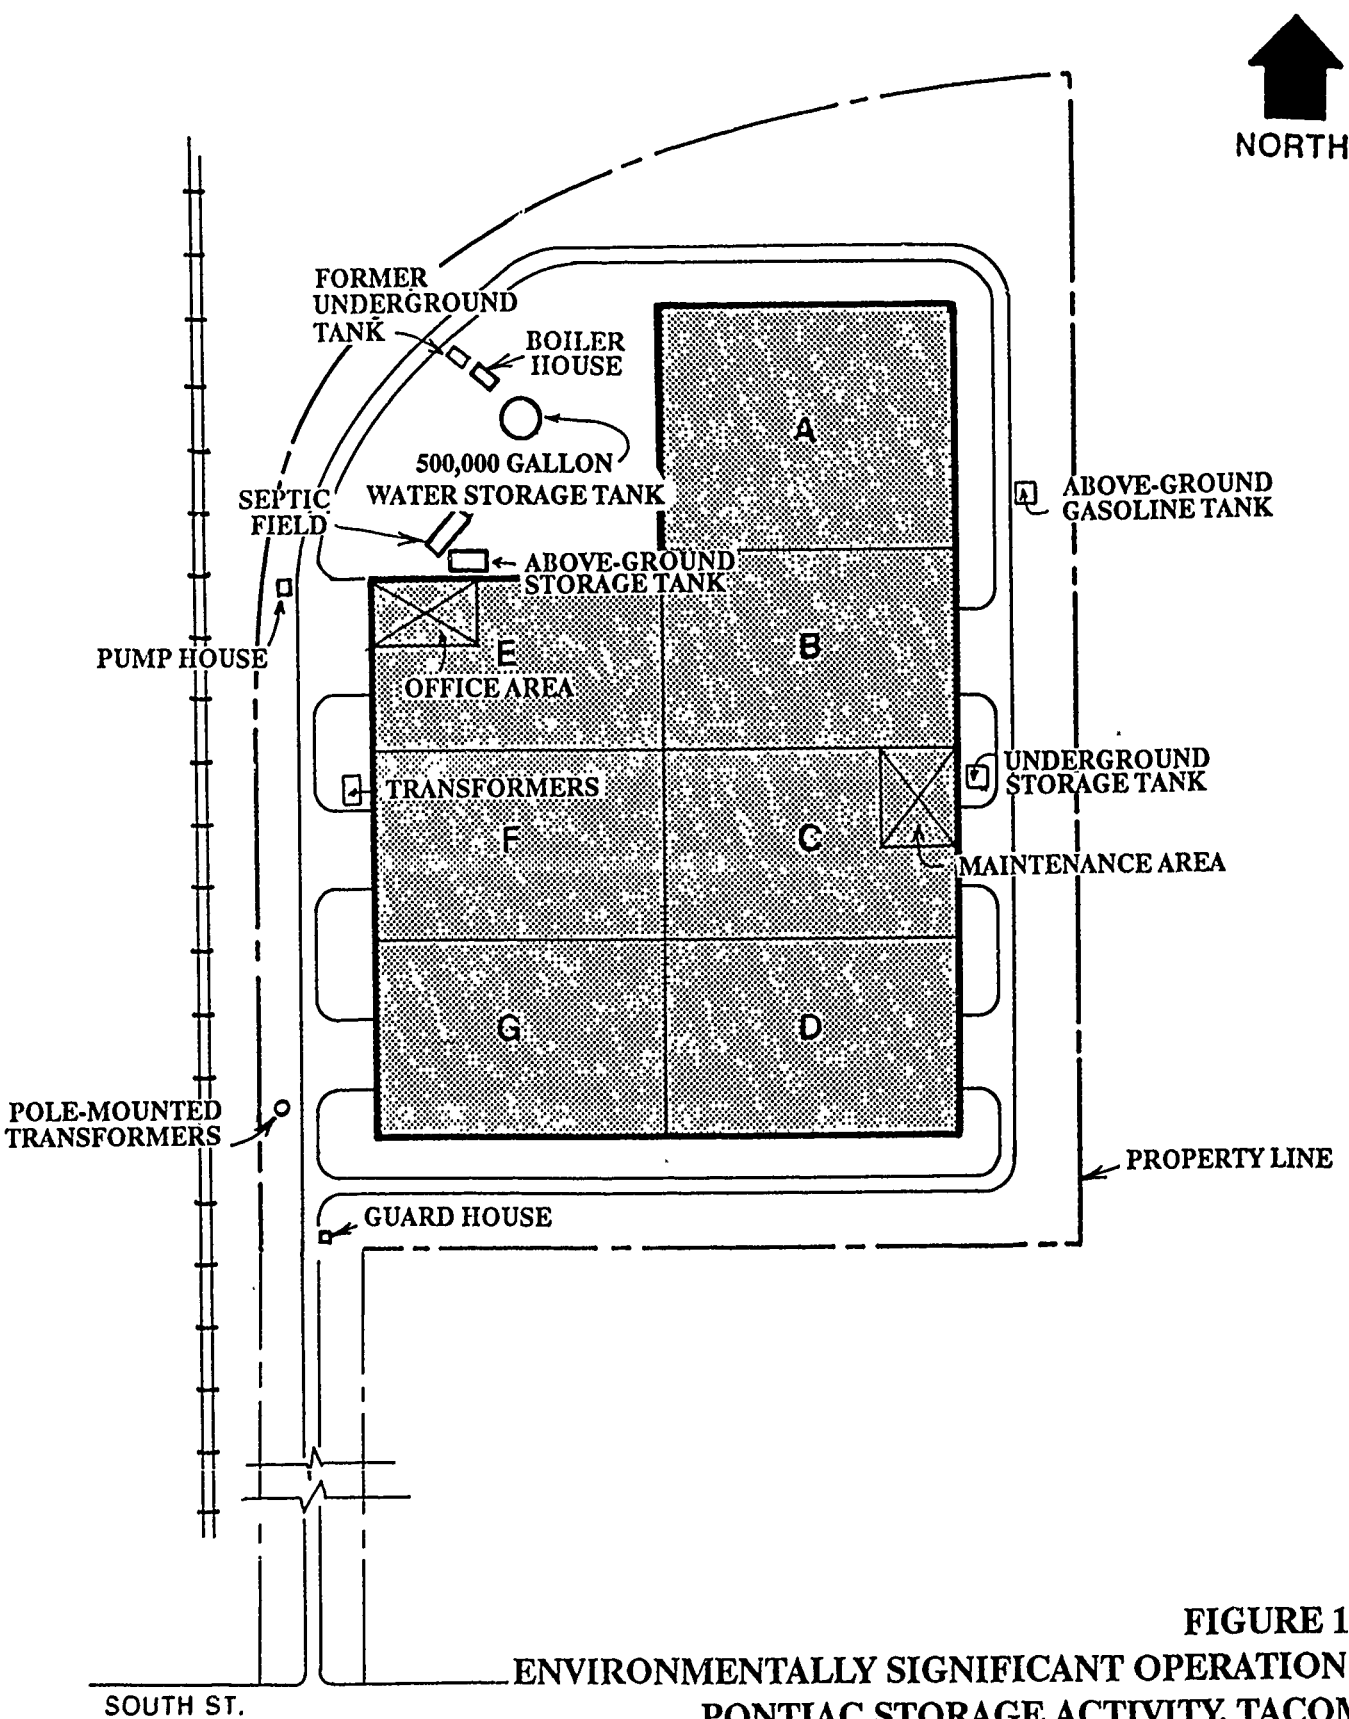
FIGURE 15
 ENVIRONMENTALLY SIGNIFICANT OPERATIONS
 PONTIAC STORAGE ACTIVITY, TACOM
 PONTIAC, MICHIGAN

During the visit to the PSA, E. C. Jordan observed dead grass and slightly darkened soils near the fill port of the existing UST. The dead grass and staining sloped to the drainage ditch located east of the main building and west of the facility's service drive. It is believed that the dead grass and stained soil are attributable to spills of diesel fuel released as overfill during fill-up operations.

The apparent release of fuel is an existing environmental threat to the surface and subsurface soils of the site and, due to migration and the potential for spill reoccurrence, a potential environmental risk to the surface waters and groundwater in the area. Measures need to be taken to assess the extent of contamination in the area, remove/treat contaminated resources, and ensure that

The 1,000 gallon tank stores heating oil used to heat the office area located in Section E. This tank is not equipped with secondary containment and is located on concrete saddles above uncovered soil. The 600 gallon gasoline tank stores fuel for vehicles used at the site. The tank is located with its dispensing pump in an asphalt bermed area. The base of this secondary containment system also appeared to be constructed of asphalt. Several cracks in, and missing pieces of, the berm were observed.

Discolored soil and dead grass were observed at the southeastern corner of the gasoline tank containment area in proximity to the cracks in the containment berm. It is believed that this staining is attributable to losses of gasoline which are not adequately collected by the gasoline tank's berm. The stained soil/dead grass area covers approximately 25 square feet and slopes with the site grade to the east.

future releases do not occur.

surface water located at the site and offsite on neighboring properties. Measures need to be taken to a) determine the extent of contamination caused by these fuel releases, b) remove and/or treat the contaminated resources, and c) ensure that future releases do not occur.
